Playground Safety Inspection Report

Site	Sample Elementary School (Small Play Area)
Inspection Date	July 29, 2026
Inspector	Petros Papageorge, CPSI
Inspection Type	Comprehensive Playground Safety Audit (CPSC / ASTM F1487)

SafeCheck Inspections LLC

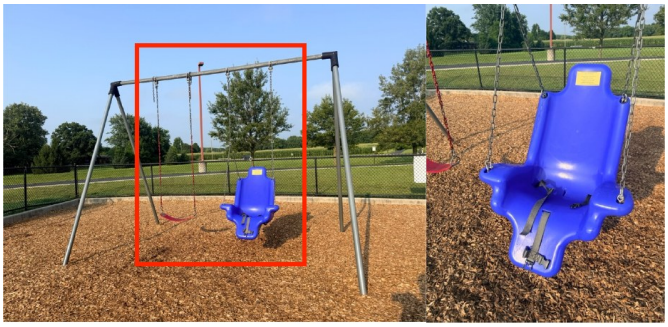
9-1) Swings: 1 Bay / 2 Seats

S-hook openings greater than 0.04 in. (about the thickness of a dime) create an entanglement hazard. Close S-hooks fully.

Open S-hooks create entanglement hazard (Priority 2)
